# DigiLink DLC100 - Optical Transmitter, Receiver, Transceiver, or Repeater for HD-SDI, SD-SDI, SDTI, DVB-ASI, and ATSC

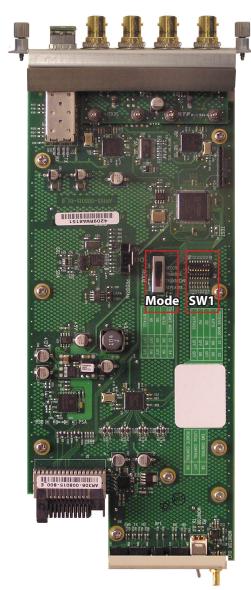
# **DIP Switch Configurations**

SW1 Configuration			
<b>S1</b>	S1 S2 Receive Mode		
On	On	Auto	
On	Off	SD	
Off	On	HD	
Off	Off	Bypass

<b>S</b> 3	<b>S4</b>	Transmit Mode	
On	On	Auto	
On	Off	SD	
Off	On	HD	
Off	Off	Bypass

<b>S5</b>	<b>S6</b>	<b>S7</b>	Input Source	
On	On	On	BNC In	
Off	Off	Off	Backplane 1	
Off	On	Off	Backplane 2	
Off	Off	On	Backplane 3	
Off	On	On	Backplane 4

Function	Off	On	
S8	EMS	Local	Remote	
30	Override	Control	Control

Factory Default: All On
