InfinityLink ILC274D - SD-SDI, ASI Digital Video 4 Ch TDM De-Multiplexer

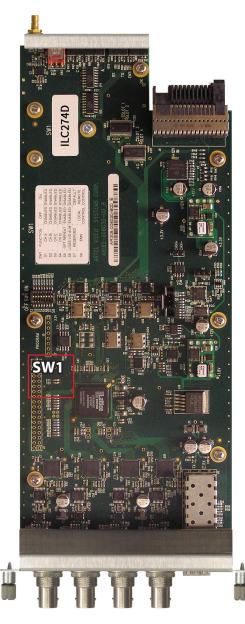
Configuration Switch Functions

SW1 Configuration				
SW1	Function	Off	On	
S1	Ch A Operation	Disabled	Normal Operation	
S2	Ch B Operation	Disabled	Normal Operation	
S3	Ch C Operation	Disabled	Normal Operation	
S4	Ch D Operation	Disabled	Normal Operation	
S5	Optical TX Disable	Repeater Operation	Disables transmitter/ repeater	
S6	Video Alarm Disable	Alarm on video loss	No alarm on video loss	
S7	Reserved	-	Must be On	
S8	EMS Override	Local Control	RemoteControl

SW1 Controls the channel (A, B, C and D) output operation, enabling/disabling of the optical TX (repeater) operation, controls the loss of video alarm option, and enables the EMS over ride function.
