DigiLink DLC300 - 3G-SDI Multi-Rate Digital Video Optical Transmitter/Receiver/Repeater

DIP SWITCH CONFIGURATIONS

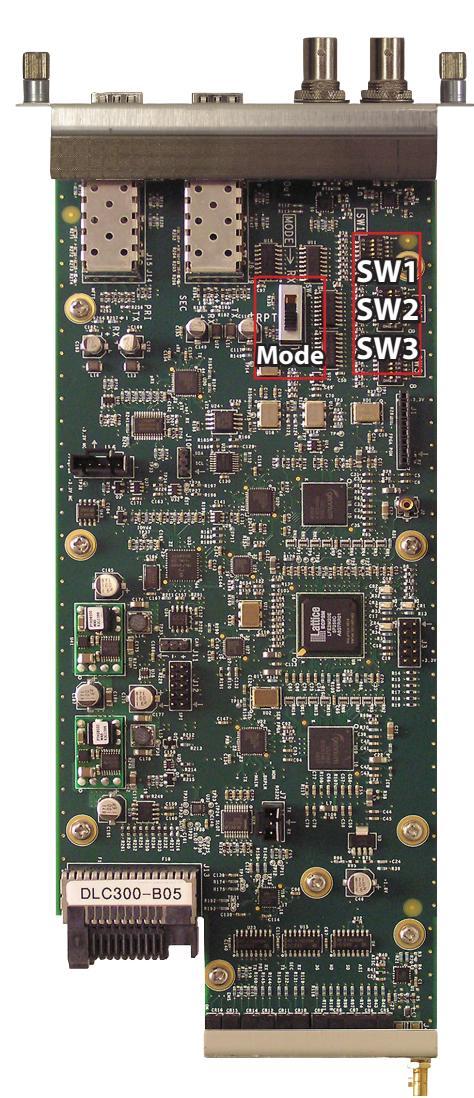
Mode Switch Functions

RX	Receiver Mode	
RPT	Repeater Mode (O to O)	
тх	Transmitter Mode

Configuration Switch Functions

SW1	Controls the video rate and forced bypass function settings
SW2	Controls the input source (BNC IN or backplane connector) for transmitter mode and operation of the standby video pattern generator
SW3	Controls the following functions: SDI processing, ATSC to ASI video conversion, SFP alarms, optical reversion, video loss alarm, and EMS enable setting
