Release Note

Date:	1/4/02	Model(s)	DigiLink 2701 (DL2701)
--------------	--------	-----------------	------------------------

Corrections to Product Manual

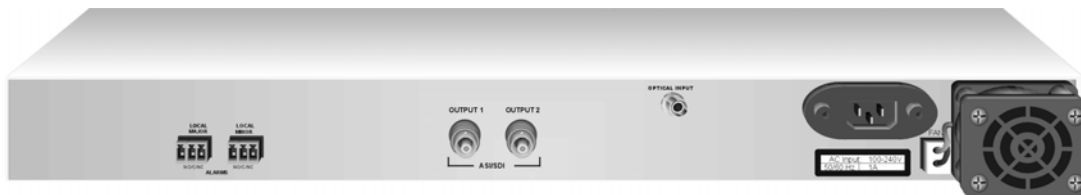
- Rear panel view (Figure 4-2, page 4-3)

DL2701 Decoder has two, not one, ASI/SDI output ports

The manual currently describes the DL2701 decoder as having only one ASI/SDI output port located on the rear panel. This product has two such ports with identical specifications as shown in the following corrected illustrations:
